I-28 Letter: Broken Front Strut

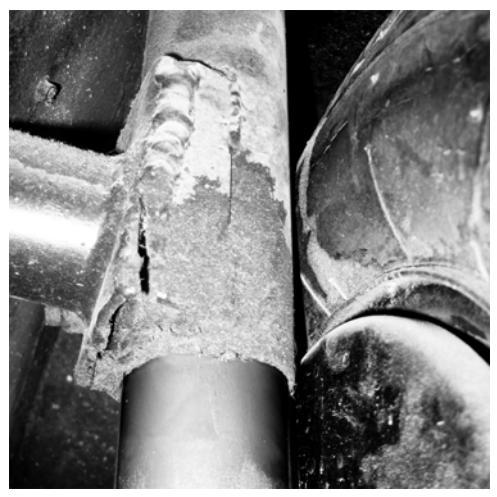
Bob: There's damage to the front axle area on the driver side of the Model 3 I just bought. Hopefully it will not be too difficult to dissemble so it can be welded? **Bob Sharp**

I'm asking Randy and John White to comment on that broken weld. It appears to me it had broken before and was rewelded, perhaps during the restoration? You can check the look of the weld on the other side of the car and see if it is similarly sloppy. Midget Motors was not noted for the quality of their welds, so it may be a factory weld. Pending Randy's advice, I'd think that weld should, at minimum, be ground smooth and even

Bob S.: Really you don't want any camber in the tubing. Only caster would be in the front tubing. I have to say I've never seen one crack there before. That piece is made from a junk of the frame rail

material and "pinched" together so the upper tube fits into it. And had maybe two welds up each side and one top and bottom to secure the tubing in it.

The tubing looks a little dry, might want to check the oil in them. The front tubes lose oil faster than the rear "shocks" do. **John**

John's right—the original tubes have no camber, but when they wear, your front wheels can wind up having negative camber, and that broken weld can increase that. Your front wheels should be at least vertical.

try to grind down into the crack as much as possible. Then when rewelding, a "hot" weld would probably be best for getting as deep as possible into the fracture, but a "cool" weld would do the least warping of the tube. The problem is that weld is right on the strut and you risk warping the tubing. Not good. Check the camber. It appears that broken weld has likely allowed the strut to pull outward and may have gotten worse over time. How to get it straight without removing the body may be a challenge, but it needs to have at least a little positive camber. Maybe you can get on it with a chain to the top of the tube and brace to the bottom, using a lever and bend it back into alignment—at least enough to hold it tight as possible while welding? By the way, that strut looks like it's not been lubricated for quite a while. If it was run dry, that may have triggered the break. **Bob V**.

Another possibility. Hook a chain or cable between the bottom of the outside sections of the two front shock tubes and use a boomer or comealong to pull that gap closed before welding. Be sure to weld in the braces as Randy suggests and you should be OK. Or use a jack arrangement as illustrated in Shop Notes 1-26. Section I-3, I-4 and others deal with front end alignment, which can be tricky. Because your car probably has high mileage, you may find the struts are worn, and various cures are available, ranging from replacement to a simple fudge-fix (I-14). Most important--oil up those struts! **Bob V.**
