J-21 Tension Rod Brackets *By Bob O.*

SHOP NOTES King Midget Maintenance and Restoration

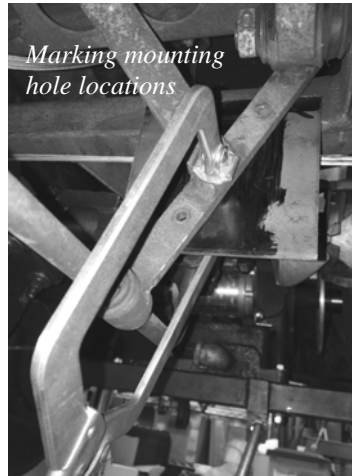
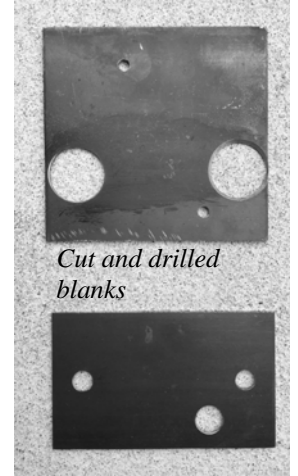
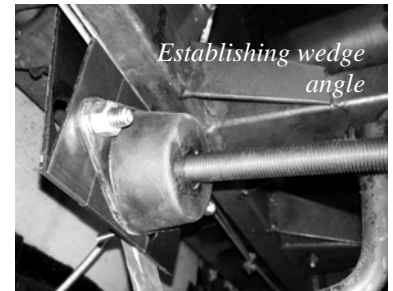
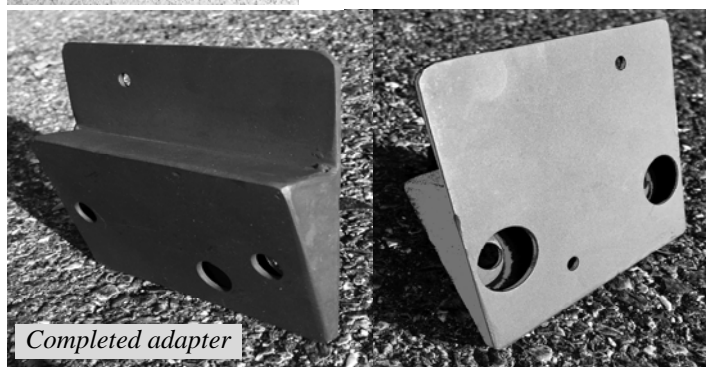
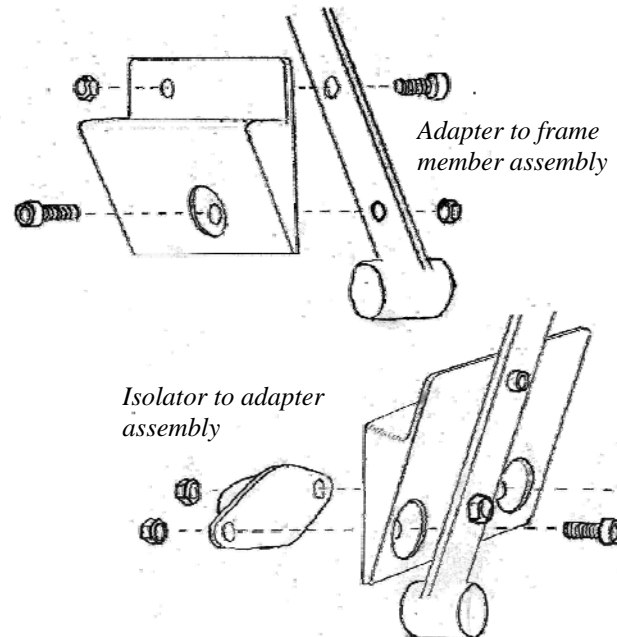
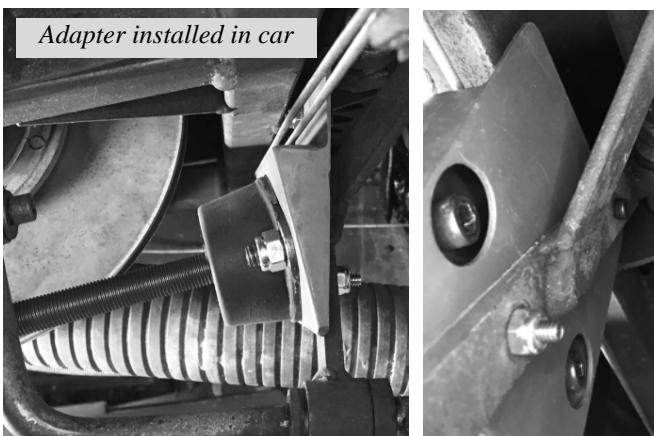
Moving the tail end of the rod down caused it to enter the isolator at enough of an angle to essentially bottom it out on one side. This partially defeated its shock-isolation capability, transferring more vibration into the car than it should, and eventually put so much strain on the isolator that the rubber began to crack and fail. Also, at this angle, the rod needed to be lengthened to fully tension the belt. I made do with a threaded coupler, a bolt, and a couple of jam nuts, but it was an inelegant solution.

Frame-side bracket: To realign the isolator with the rod, I fabricated a bolt-in wedge-shaped adapter from 1/16" steel so that I wouldn't need to do any permanent alterations to the car. The adapter consists of a square piece that bolts to the frame, a rectangle to accept the isolator (McMaster-Carr p/n 64875K28), and filler pieces to set the wedge angle. This shape creates a "step" to clear the suspension subframe. Step-drilled clearance holes in opposing sides allow bolts to be installed during assembly.

Instead of trying to work this design out mathematically, I used a "cut and try" method. I clamped the square blank to the frame member to which the isolator was originally mounted to establish the mounting hole locations. To determine the wedge angle, I taped the bottom edges of the pieces together, installed the isolator mount, and bolted this assembly to the car. After threading the tension rod into the isolator, I trimmed cardstock triangles to fit as patterns for filler pieces. I fully welded all the seams for strength, and applied a few coats of red oxide primer.

The adapter first mounts to the frame, then the isolator bolts to the adapter using socket-head bolts and locknuts as shown. The adapter corrects the entry angle into the isolator and eliminates the need to extend the tension rod.

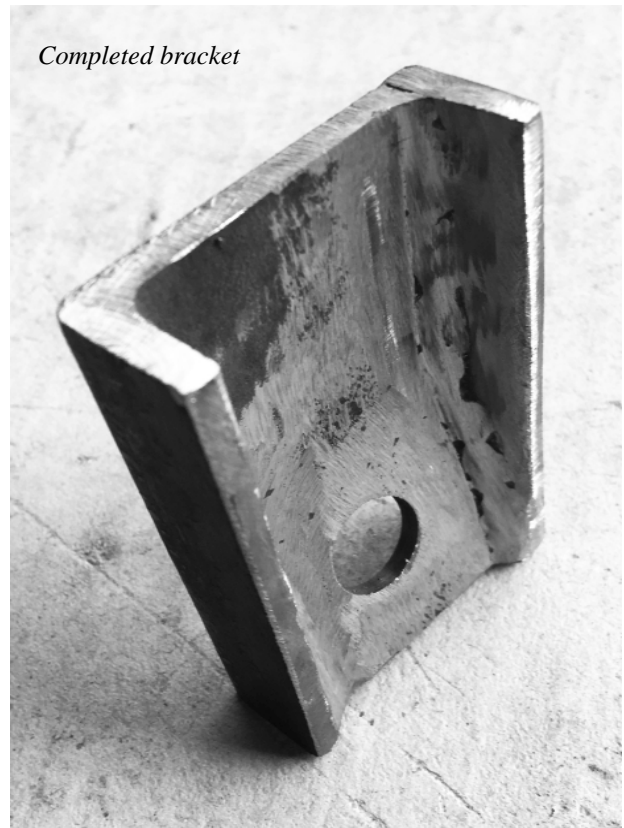
Engine-side bracket: I used the new frame-side bracket for a little while before the next weak link was exposed. My first attempt at the engine-side bracket for the tensioner was not strong enough, and it eventually cracked and failed where the rod passed through. Since I had been planning to pull the engine out for some performance and cosmetic improvements anyway, I took the opportunity to replace the bracket with a stronger piece.

Completed bracket

Prior to removing the cradle, I noted the approximate angle needed for the rod to meet the bracket at a right angle. Starting with two pieces of $\frac{1}{4}$ x 1-1/2" angle iron about 4 inches long, I used an angle grinder and a cutoff wheel to remove the "leg" from one of these to make a flat plate. On the other piece, I drilled a 5/8-in diameter hole, then cut a slot at the base of the leg about halfway up the piece. Next I used a vise and hammer to bend the free end up to the appropriate angle. I welded this piece to the flat plate to form a U-shaped channel. Finally, I cut the sides down to reduce weight and improve access to the tension rod hardware.

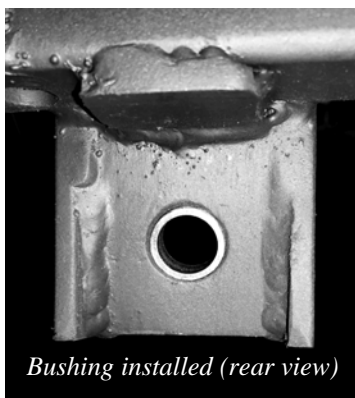
Bushing installed (rear view)

I welded this assembly to the engine cradle and gave everything a coat of paint. I ground down a bronze sleeve bushing (McMaster-Carr p/n 9440T21) to $\frac{1}{4}$ -in thickness, installed it in the 5/8-in hole, and reamed it out slightly to keep the tension rod from binding during adjustment. I used a combination of grade 5 $\frac{1}{2}$ -20 jam nuts (McMaster-Carr p/n 94846A525) and a grade 5, steel insert locknut (McMaster-Carr p/n 90619A033) on the aft end to secure the rod.

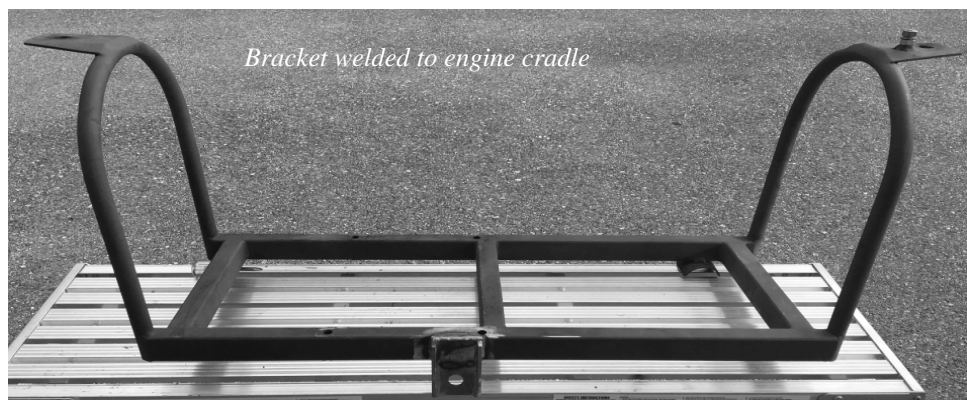
Bracket welded to engine cradle
