SHOP NOTES King Midget Maintenance and Restoration

C-25 Door Pulls *by Bob Olbers*

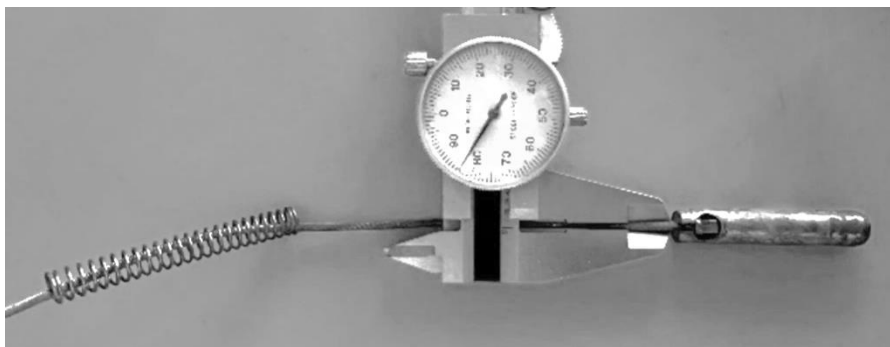
Original pull with spring and plunger

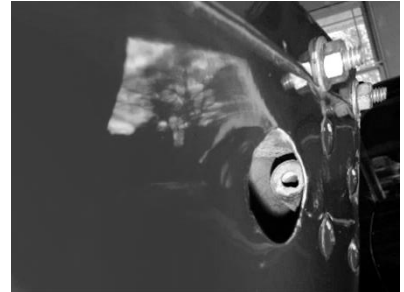
Lanyard passes through tube inside door; plunger and coil spring retract into tube from jamb side to allow door to open
