SHOP NOTES King Midget Maintenance and Restoration

C-26 Engine Cover Hold-Downs *by Bob Olbers*

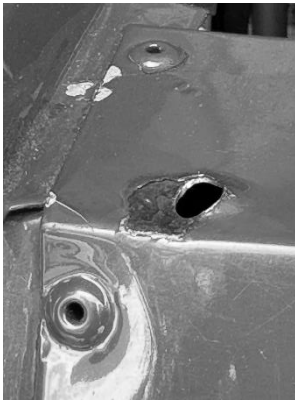
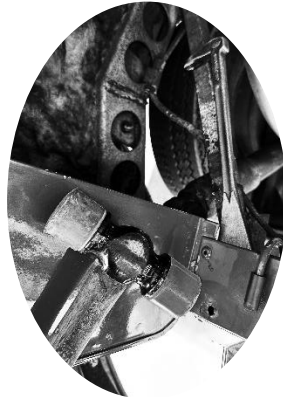
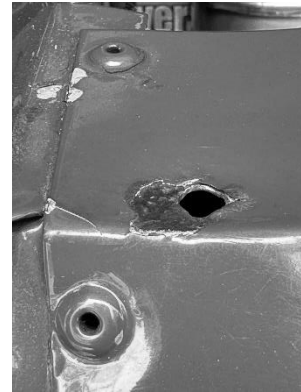
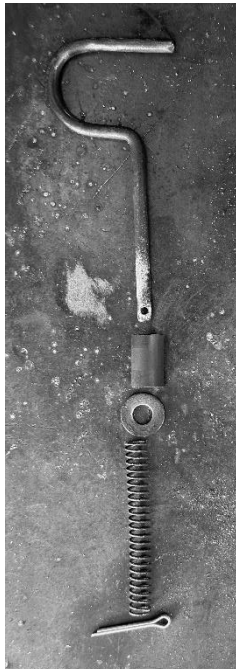
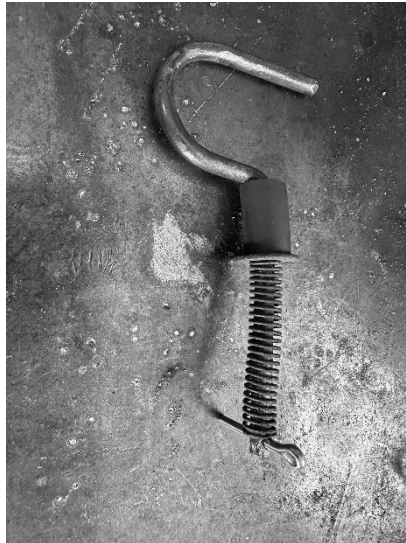
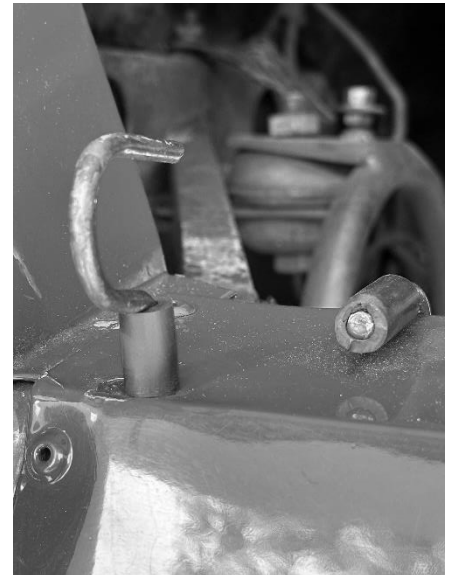
Over time, the rubber tubing on our engine cover hold-downs can deteriorate. Also, the sheet metal surrounding them can become distorted. These issues may interfere with the proper operation of the hooks. Here's how I refurbished the ones on my Model 3.

I removed the cotter pin, washer, and spring from the bottom of the hold-down and pulled the hook out from the top. I used a plastic-faced mallet and a "shark"-style flat prybar as a hammer and dolly to carefully flatten the metal around the hole without removing too much additional paint (If I had been planning to repaint the panel, I would have used more aggressive techniques and possibly welded or epoxied a washer to the underside to provide additional support). After sliding a ½" length of 3/16"-ID x 7/16"-OD rubber tubing over the hook, I reinserted it into the hole and reassembled the washer and spring. I secured the assembly with a new 3/32" x 1" cotter pin, and repeated this process for the other hold-down.

The refurbished hold-downs look much better and do a much better job of keeping the engine cover closed. ◻
